WHITE'S POND DAM

NH 00106

PHASE I INSPECTION REPORT NATIONAL DAM INSPECTION PROGRAM

AUGUST 1978

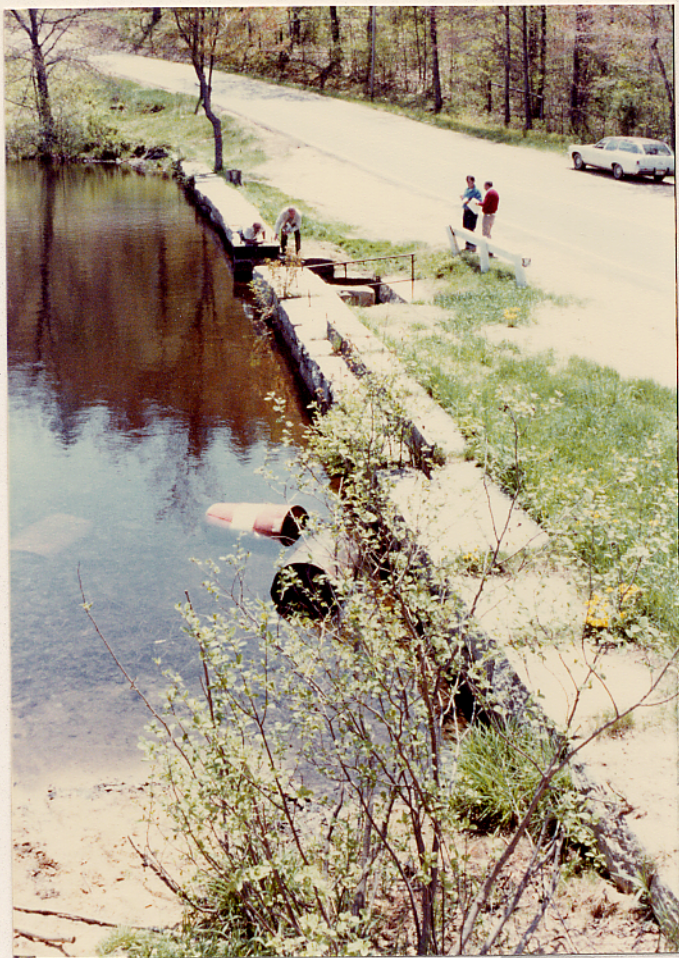
Overview from right abutment

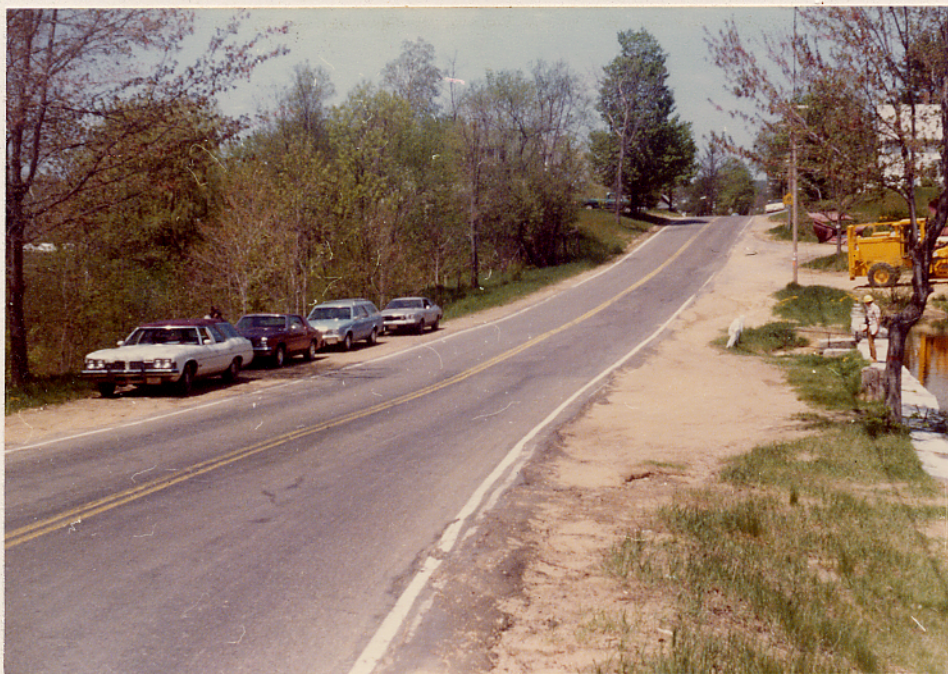
Overview from left abutment

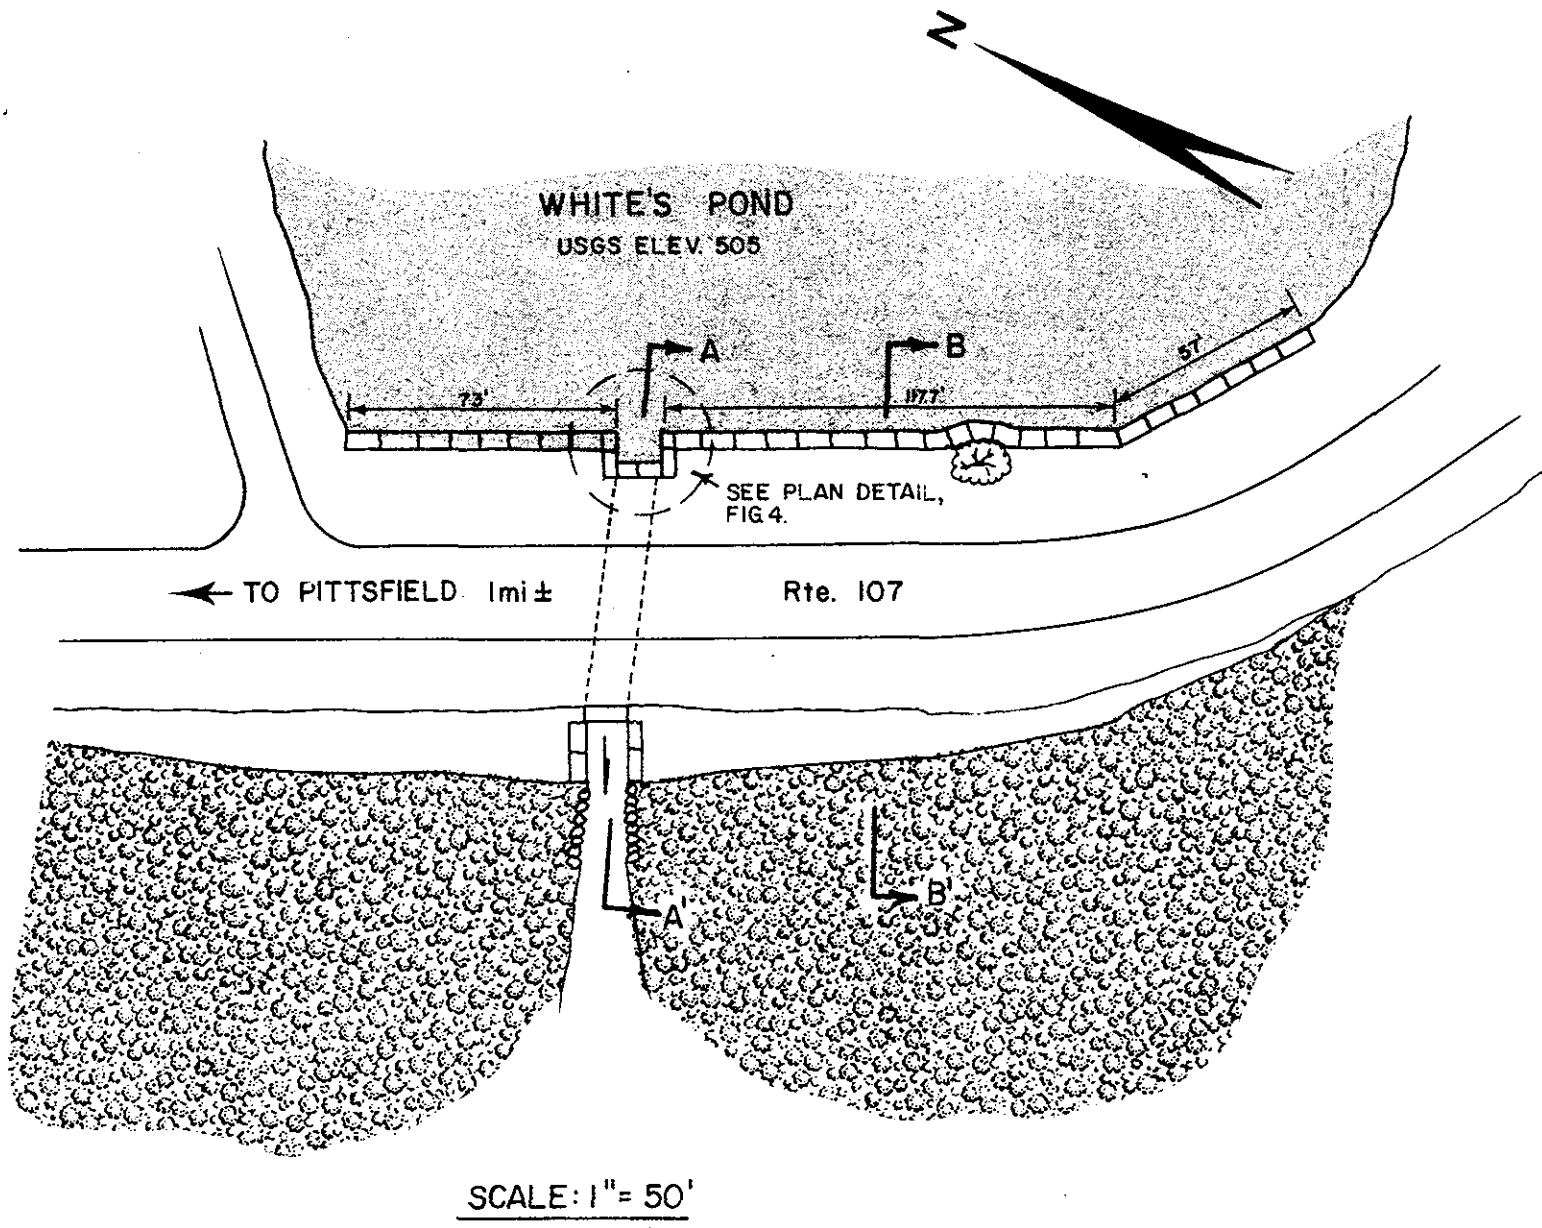
SECTIONS

The double courses of granite, with capstone, which form the dam proper were somewhat unequal in alignment, consistent with early construction techniques (Fig. 3 and Overview Photos). However, displacement pond-ward is evident probably caused by former trees, since removed. One tree, a probable contributor to the movement, still remains. Since the outlet of the dam is located opposite the sag point of Rt. 107 with no controlled drainage, storm runoffs flow towards the flume section and the outlet headwall. This condition has caused surface scour adjacent to the flume walls (Photo 1) and undermining and loss of ground at the northeast wing wall.

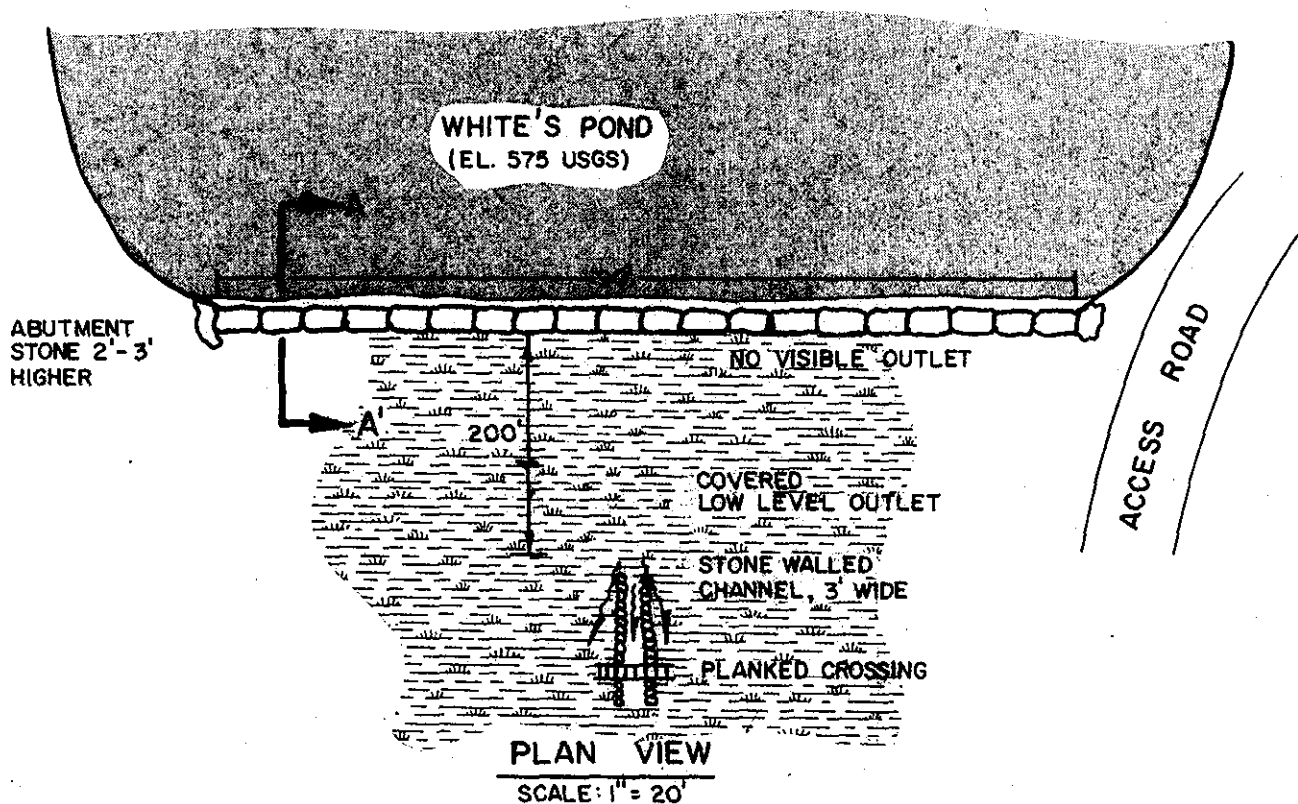
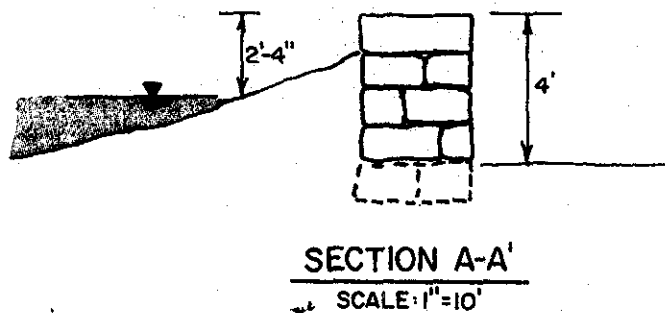
The 90 foot long, 4 foot high closure structure on the northside of the pond is, as is the dam proper, constructed of double-wall granite blocks with capstone (Figure 6). It has recently been remortared in several locations, and is in fair condition.

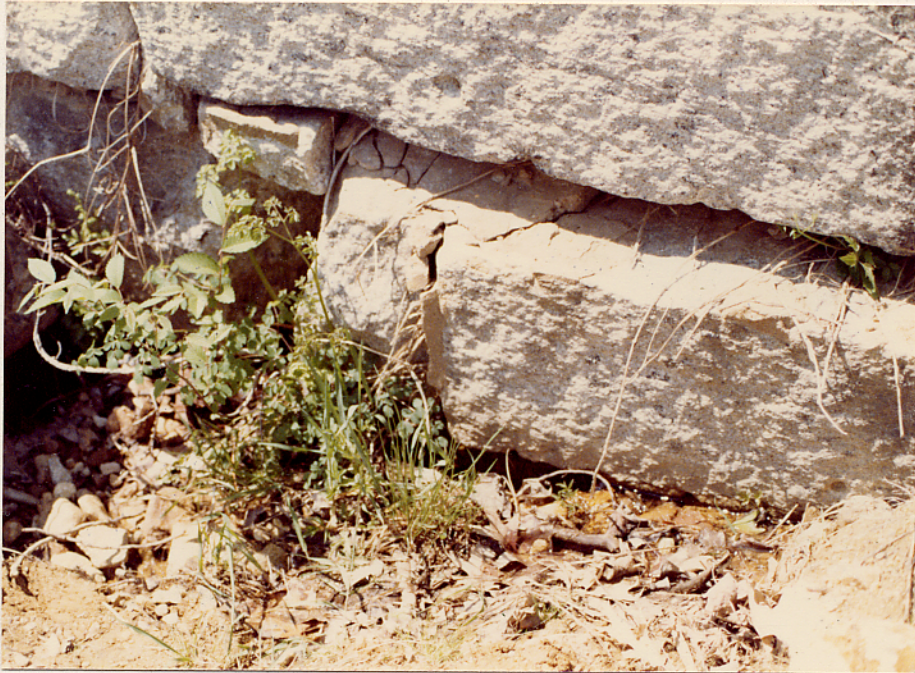
Leaks through open masonry joints are evident at both abutments of the outlet works (see Photos 2 and 3). The downstream side of Rt. 107, which is considered as integral to the dam is overgrown. Minor seepage (less than .1 gpm) was observed 22 feet left of the downstream outlet, 3 feet above toe of slope. Considerable oil was contained in the seep, indicating a possible origin in the road surface. The seepage could not be observed on a later inspection June 21.

1. Leaks through open joints in granite blocks adjoining right side of spillway

The granite joints must be effectively sealed in order to prevent seepage. This seepage, particularly during cold weather conditions, has progressively caused the block coursing in the flume to deflect outward. Progressive deflection will unravel the flume walls which could conceivably result in spillway failure.

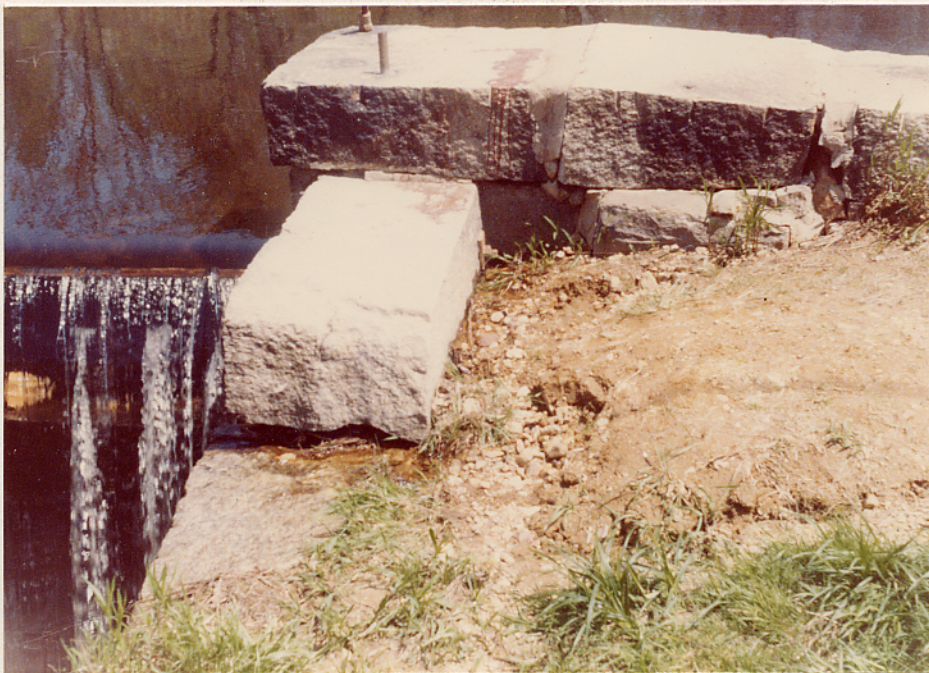
2. Leaks through open joints in granite blocks adjoining left side of spillway

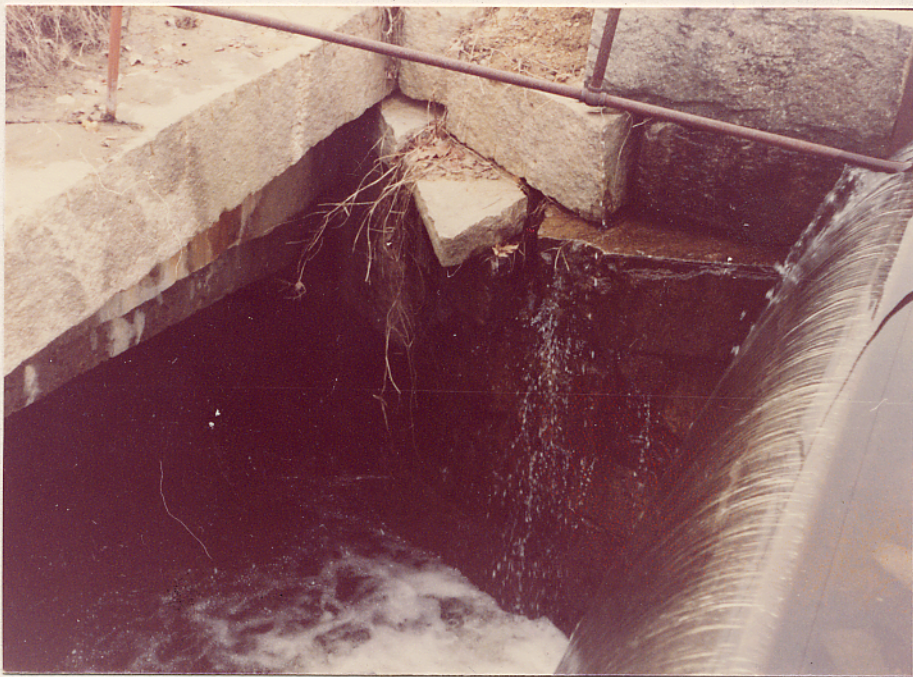
The spillway structure consists of squared stone granite masonry with unmortared chinking stones (Figures 3, 4, and 5). The spillway is 11.5 feet long by 3.3 feet wide with a 10 foot vertical drop between the spillway sill and the flume invert. A nominal 3 inch by 21 inch timber stop-log is set on top of the spillway and secured by means of restraining angles bolted to the sidewalls of the adjacent flume. The invert of the spillway is 3.7 feet below the top of the granite block facing of the dam. It was observed that continuous seepage is permeating through the second joint coursing of the granite dam facing adjacent to both sides of the spillway; the second capstone joint being below pond level (Photo Nos. 2 and 3).

3. Spillway from left side showing leaks through masonry

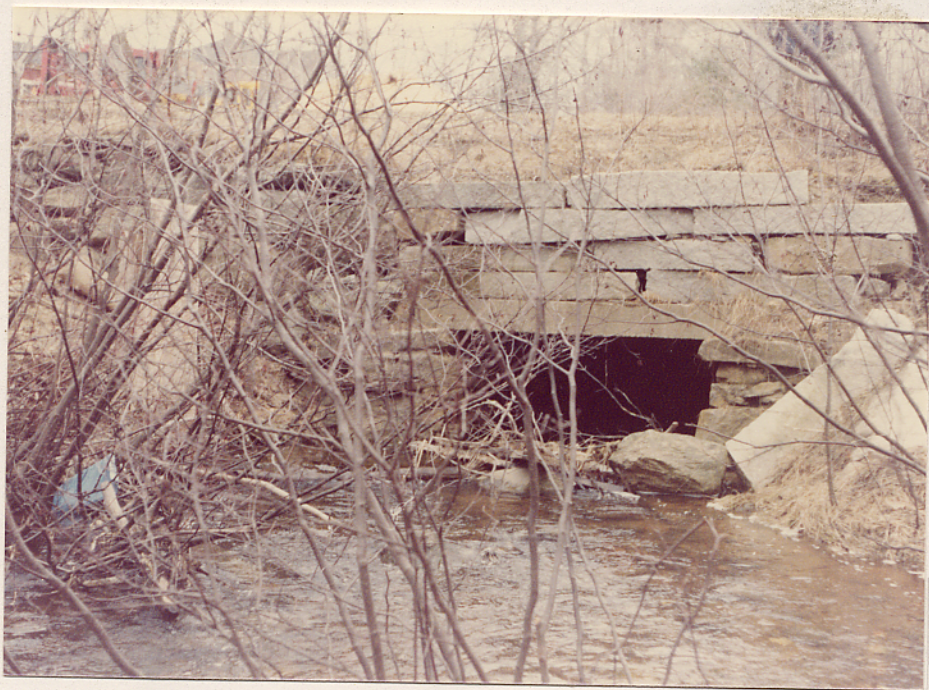
4. Downstream outlet beneath Route 107

The distressed granite header must be replaced in order to preclude structural failure which could block the outlet of White's Pond. A major obstruction in the outlet structure could result in a roadway washout and undermining of culvert sidewalls. Increased culvert capacity will be required to discharge the STF, unless highway reinforcement proves a viable alternative.
